Materials Characterization of Irradiated Spectralon from the NIF Target Chamber

R. Chow, G. Frieders, W. Jensen, M. Pearson, P.
Datte

May 22, 2015

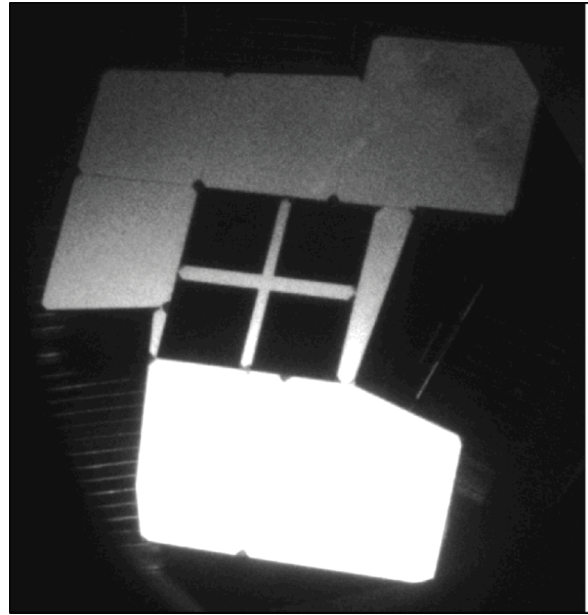
The picture in Figure 2b of NBI Q31 shows little visual evidence of shot-induced degradation. NBI Q31B had been in service for about 4 years and experienced a cumulative neutron and gamma radiation dose of 0.0384 Gy. It was not until the cumulative dose reach about 0.0826 Gy that reflectivity degradation was observed in various parts of the assembly.

Figure 2b Image taken on June, 2011, of the NBI assembly on Beam Quad 31. Note the lack of defects although the assemblies have been irradiated with a cumulative dose of 0.0384 Gy, about 4 years of service in the target chamber.

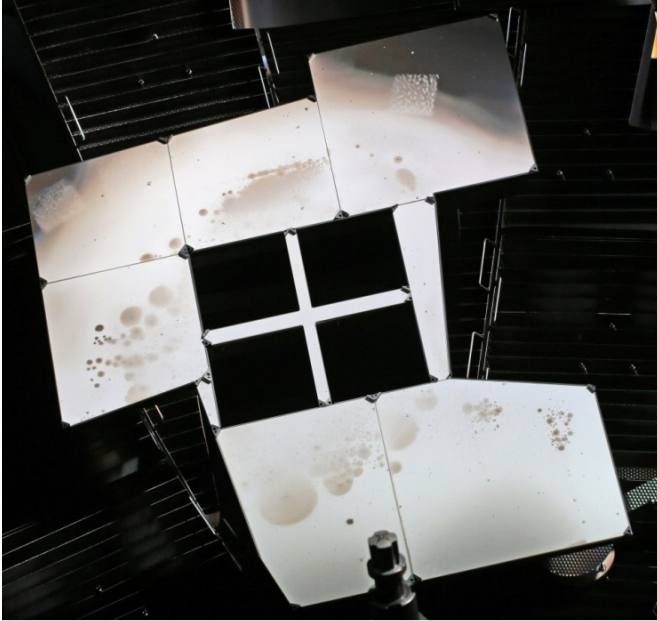
The situation is reversed on the NBI Q31 assembly, located near the south pole of the target chamber. During the time frame when the localized reflectivity changes were tracked, the camera imaging system did not have sufficient resolution to determine if the defects were forming

Upon removal from the target chamber and disassembly, the top surface of the cover glass was clean except for pitting from target debris. The bottom of the cover glass was smooth and there was no visual evidence of pits extending to the backside of the glass. The underlying Spectralon was the source of the reflectivity changes. The localized reflectivity changes appear as discolored, charred Spectralon.

Figure 3a NBI Q31 assembly prior to removal on April, 2014. NBI Q31 is located near the south pole of the target chamber. Note the spatially localized reflectivity degradation of the Spectralon sub-assemblies.

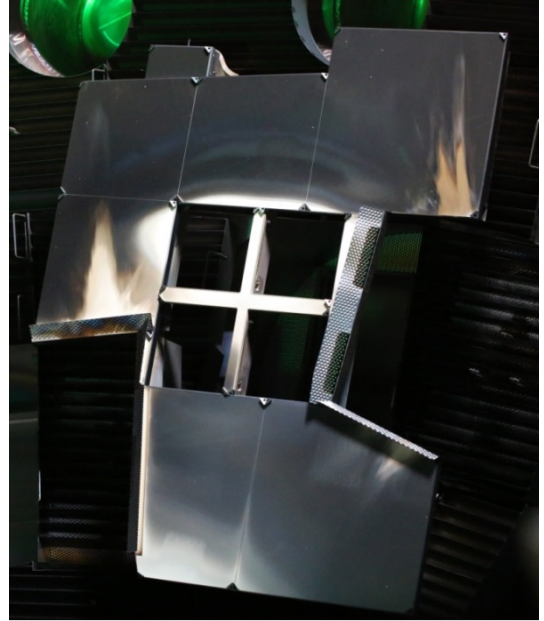
The close-up photographs of two NBI assemblies are shown in Figures 3. The NBI Q36 assembly, near the equator of the target chamber, was almost completely darkened by the time this study was initiated. Upon removal from the target chamber and disassembly, the top surface (facing the target) of the cover glass was metallized and pitted with target debris, but the underlying Spectralon was pristine in appearance (See Figure 4.)

Figure 3b NBI Q36 assembly prior to removal on April, 2014. NBI Q36 is located near the equatorial level of the target chamber. Note the metallization of the cover glass.

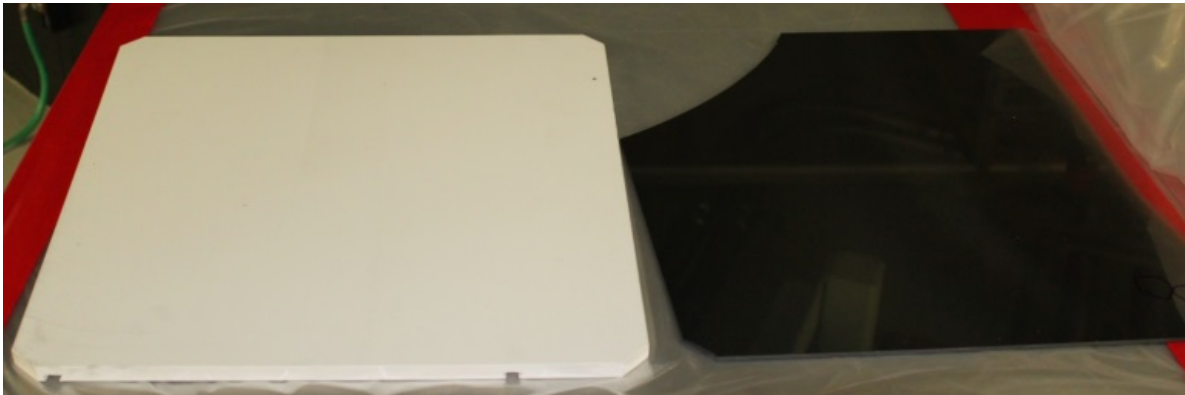
Figure 4 Typical Spectralon and cover glass from a NBI Q36 sub-assembly. The Spectralon is pristine in appearance. The cover glass is metallized.

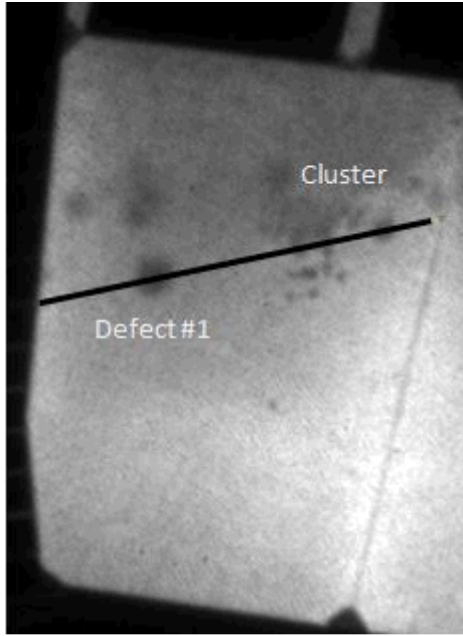
In Figures 5, the lower left NBI Q31 sub-assembly shows defect clusters and different regions of reflectance. A line was drawn across defect clusters that grew in a measurable manner. One of the defects is labeled as Defect #1. There are some defects that appeared to grow as rapidly but they eventually merged with other defects within the cluster.

Figure 5a NBI Q31B defects with rapid growth are noted along the line drawn by software. Image taken April 2012.

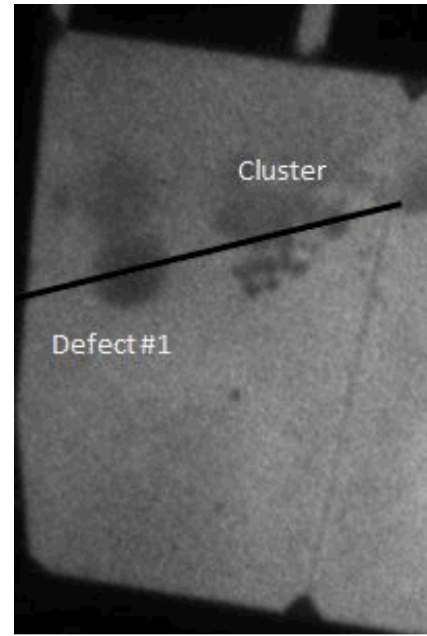
Figure 5b NBI Q31B defects merged together in the area labeled Cluster. Image taken November 2012.

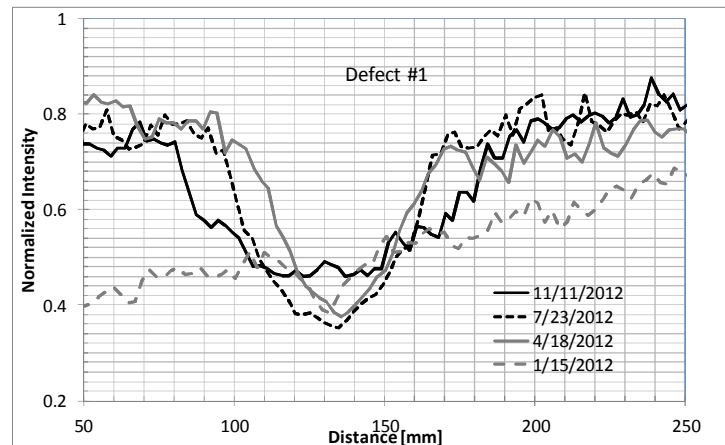
The growth rate of Defect#1 was determined from 4 images taken on Jan, April, July and November of 2012. A 1Mp scientific camera⁶ captured the images using the illumination from the NIF chamber camera view imaging system. The ImageJ software⁷ was used to measure the intensity across the defect from which the diameter was measured at FWHM. The pixel-to-length conversion was calculated from the nearest aperture edge of the quad opening. The normalized intensity profiles from Defect #1 are shown in Figure 6 for the given dates. The growth rate was calculated to be 0.212 mm/day.

Figure 6 Defect #1 line-outs of its normalized intensities

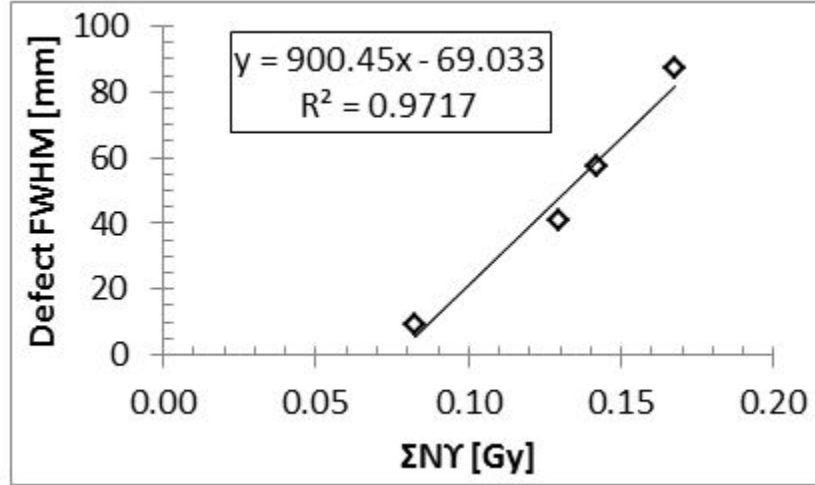
Figure 7 Defect growth as a function of cumulative neutron and gamma radiation dosage, ΣN_{γ} . Growth rate is 900 mm/Gy.

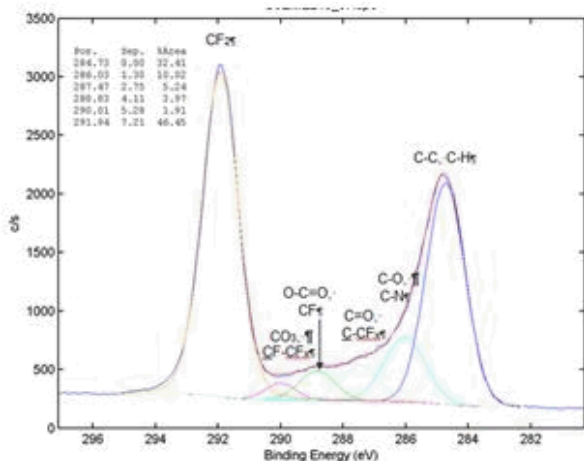
Figure 10a XPS spectra from sample White-1. Note the relatively high counts at the CF_2 binding energy at 292 eV and low counts of C-C and C-H molecules at 285 eV.

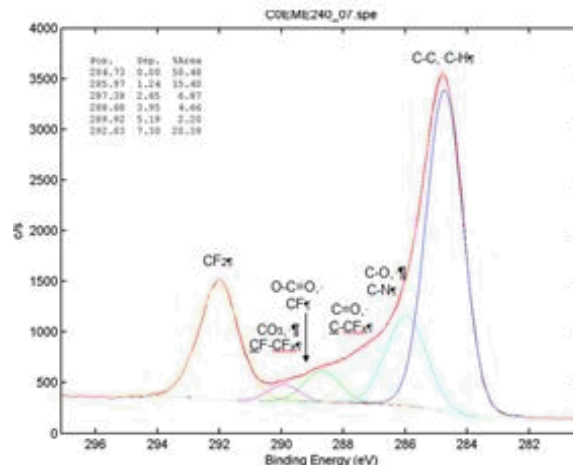
Figure 10a XPS spectra from sample Black-1. Note the relatively low counts at the CF_2 binding energy at 292 eV and high counts of C-C and C-H molecules at 285 eV.

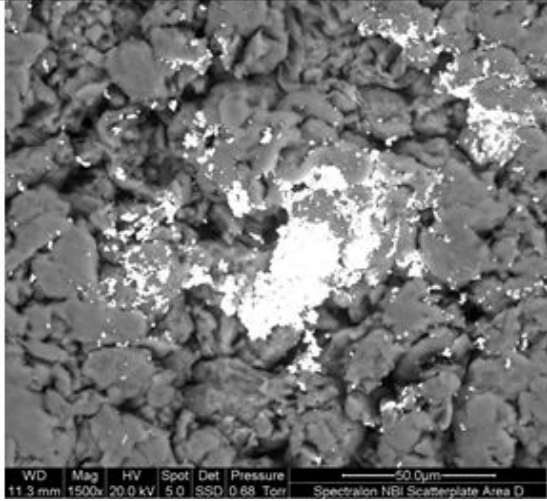
<p data-bbox="358 835 730 863">Bright, Round particle: C, F, O, S, Ti</p>

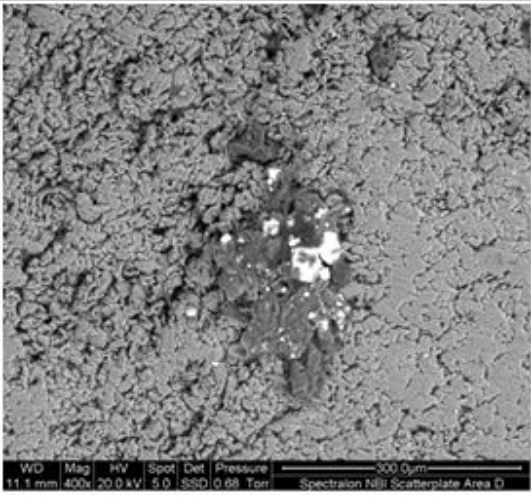
<p data-bbox="868 835 1341 863">Bright, Cubic particle: C, F, O, Na, Al, Si, Cl, K</p>
Brown2

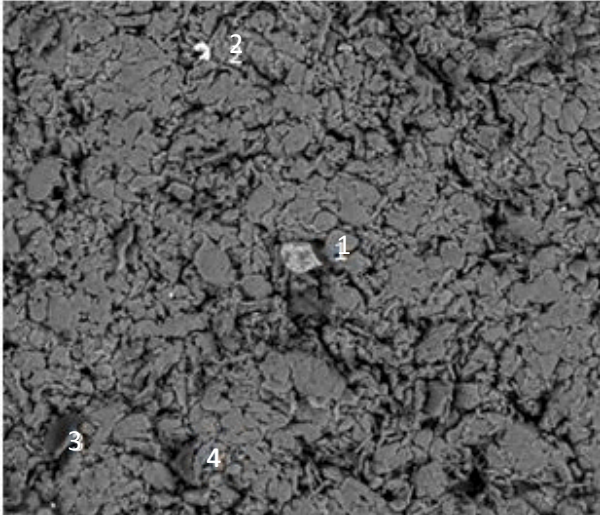
<p data-bbox="240 1430 630 1535"> Particle 1: C, F, O, Na, Al, Si, Cl, K, Ca Particle 2: C, F, O Na, Cl, K Particle 3: C, F, O Particle 4: C, F, O, Na, S, Cl, K, Ca </p>	<p data-bbox="1084 1167 1187 1194">No Image</p>

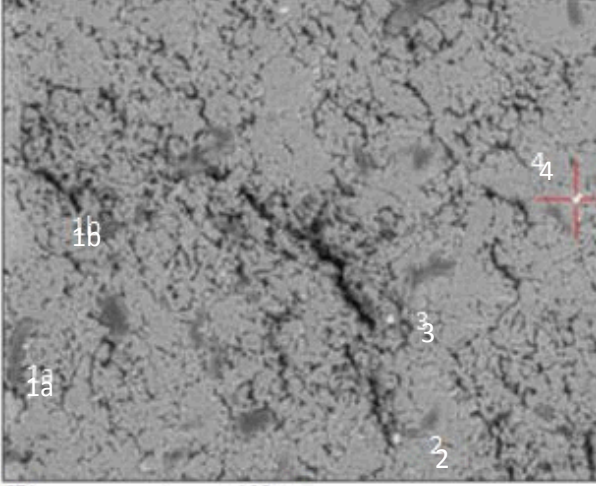
<p>SE1 100µm</p> <p>Dark Particles 1a, 1b: C, F, O Bright Particle 2: C, F, O, Na, Mg, Al, Si, K Bright Particle 3: C, F, O, Mg, Al, Si, Ca Bright Particle 4: C, F, O, Zn</p>

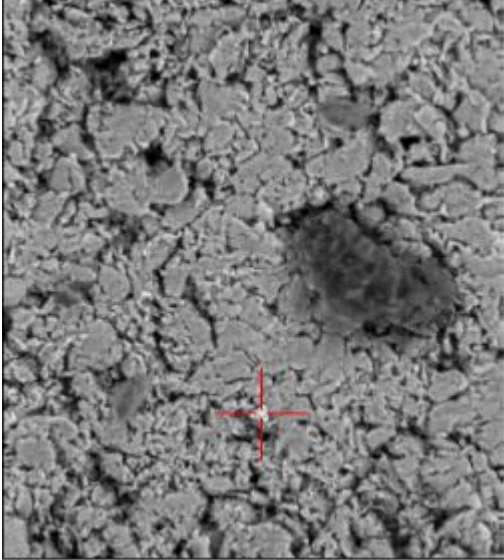
<p>SE1 50µm</p> <p>Bright Particle 6: C, F, O, Na, Al, Si</p>
Black2

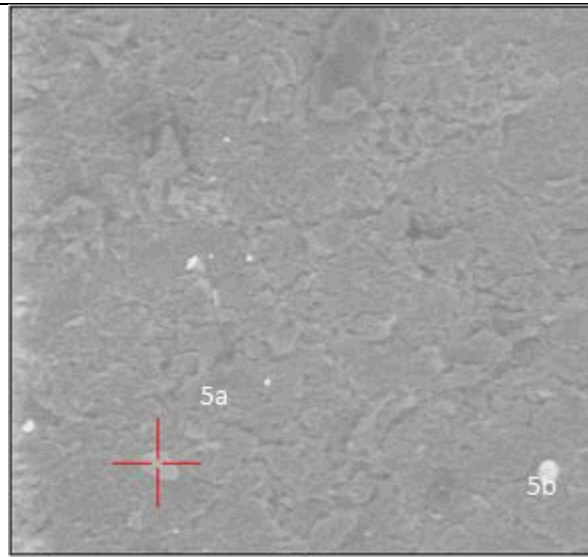
<p>SE1 100µm</p> <p>Bright Particles 5a and 5b: C, F, O, Al</p>

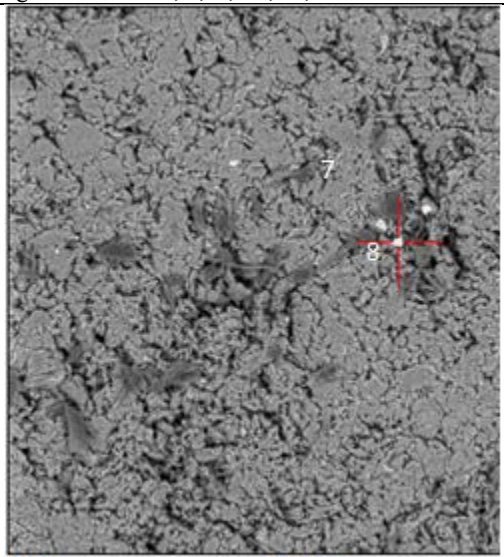
<p>SE1 100µm</p> <p>Bright Particle 7: C, F, O, Na, Mg, Ca Bright Particle 8: C, F, O, Si, Fe</p>

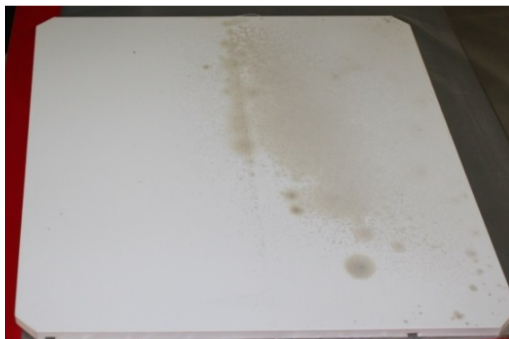
Figure 11 Defects preferentially aligned to a seam in the Spectralon plate. The seam appears to seed defect growth. Defects are prevalent on the right section of the plate and not the left section.

Possible options to purify the Spectralon, especially at the surface illuminated by the UV light, may be to deposit high purity Spectralon onto the backside of the cover glass. The coated glass would be backed up with a thick Spectralon plate to maintain the optical scattering properties.¹⁹ A Spectralon coated cover-glass would have the extra advantage of protecting the illuminated surface from contamination due to handling and installation. Painting a high purity solution of Spectralon on the surface has been attempted but this application process leaves streak marks of irregular reflectances. LPCVP,²¹ thermal evaporation,^{22,23} and RF sputtering²⁴ to create PTFE-like films has been demonstrated. However further study is needed to verify that the Spectralon coatings are purer than the bulk-fabricated Spectralon and the optical properties are acceptable for the NBI diagnostic.
